### RESULTS OF EXAMINATION OF THE RETURNED SURVEYOR 3 SAMPLES FOR PARTICULATE IMPACTS

*B. G. Cour-Palais, R. E. Flaherty, R. W. High, D. J. Kessler, D. S. McKay, and H. A. Zook*

### MICROCRATER INVESTIGATIONS ON SURVEYOR 3 MATERIAL

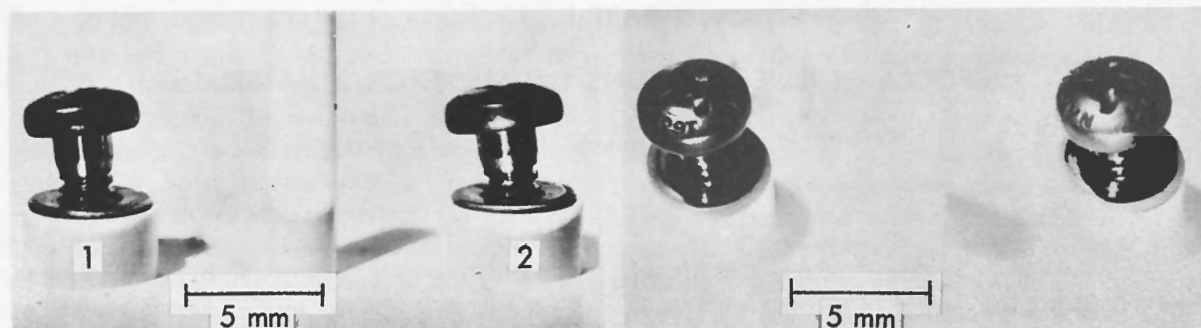
FIGURE 2.—Surveyor 3 screws with washers.

Figure 2 shows the two screws including the washers. The investigations were made using a scanning electron microscope (Stereoscan). The scanning magnification was chosen to be  $5000\times$ , which allowed the identification of craters down to about  $0.5\text{ }\mu\text{m}$  in diameter.

The original surfaces of the screws and washers were not specially prepared in any way for scientific investigations. They are rough and probably inadequate to yield reliable results. On screw 2<sup>1</sup> (see fig. 3), strange features could be observed. Figure 4 shows six interesting objects on screw 1; these objects can be considered as impact phenomena.

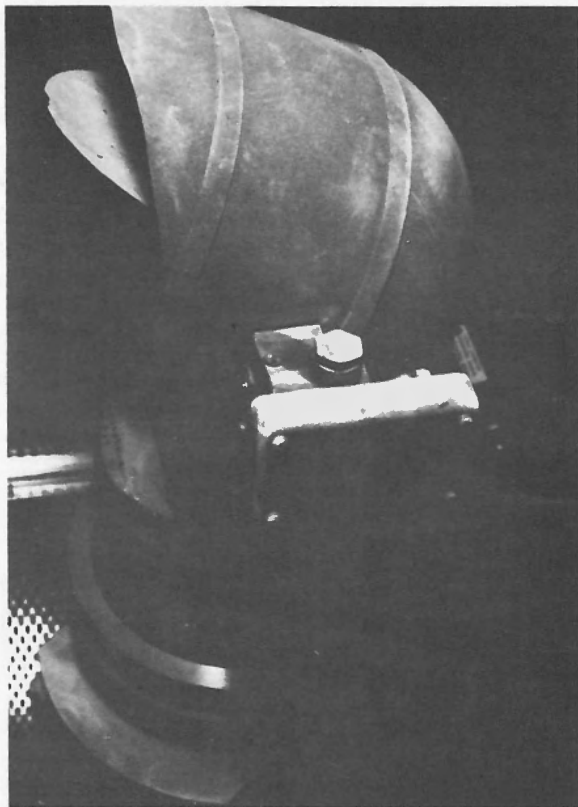
FIGURE 5.—Evidence of particle impact shadows on the camera housing.

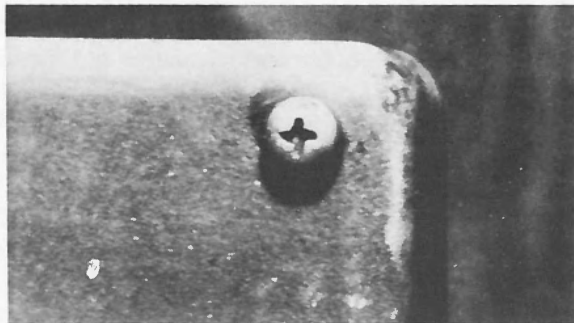
FIGURE 6.—Evidence of particle impact shadows on the camera housing.

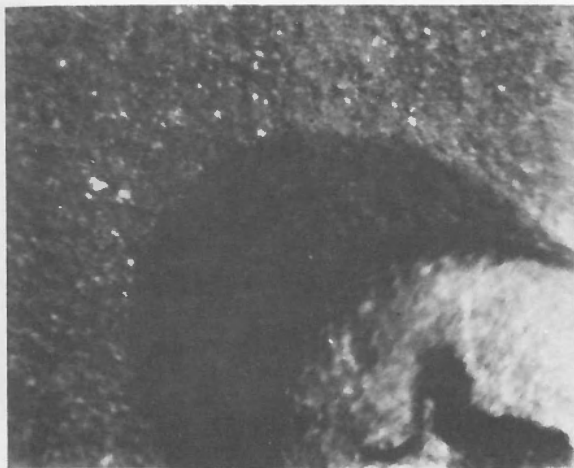
FIGURE 7.—Evidence of particle impact shadows on the camera housing.

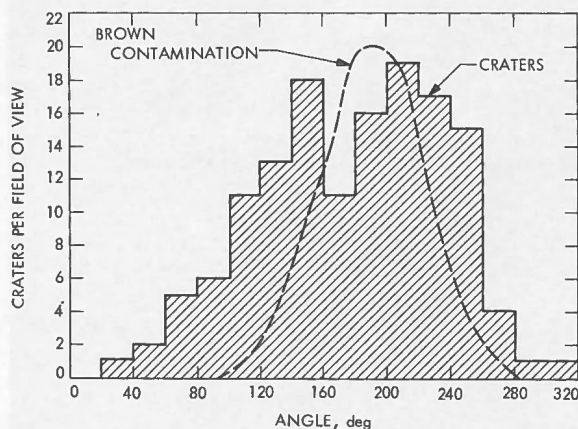
FIGURE 10.—Distribution of brown contamination and of impact craters.

Figure 10 shows the number of craters with diameters of  $20\text{ }\mu\text{m}$  and larger that were observed in the field of view of an optical microscope at  $100\times$  magnification (corresponding to an area of about  $1\text{ mm}^2$ ). Counts were taken as a function of angle around the tube from the scribe line, which had been ruled along the tube before cutting. This histogram is an average of two trials on section B of the tube. Very high pit densities (up to 40 per field of view) were obtained in two places, but were obviously associated with scratches and so are not included in figure 10. The reduced count rate about  $170^\circ$  from the scribe line is not considered significant.

Also shown in figure 10 is a measure of the relative amounts of brown contamination on section B as a function of angle around the tube. This curve was obtained by photographing the

tube at each angular position, as the tube was rotated and the lighting held constant. The contamination stood out in the photographs between the angles of  $100^\circ$  and  $280^\circ$  and seemed to peak at about  $190^\circ$ . Outside of these angles, section B was relatively clean. The relative heights of the ordinate of the contamination curve in figure 10 are not quantitatively significant. A high ordinate means that the photograph indicates "high" contamination relative to an angular position with a ordinate. It is immediately evident that there is a close association between the pitting rate and density of the brown contamination.

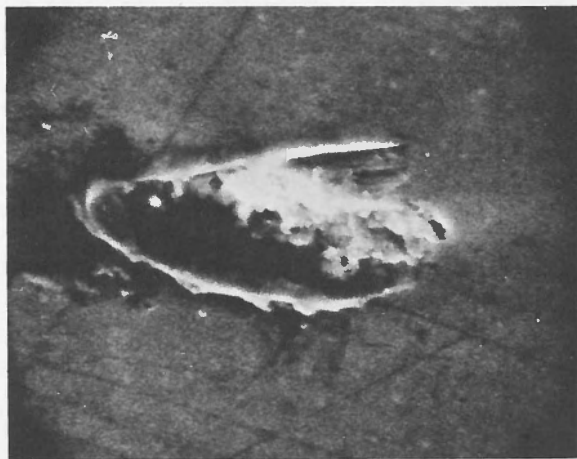
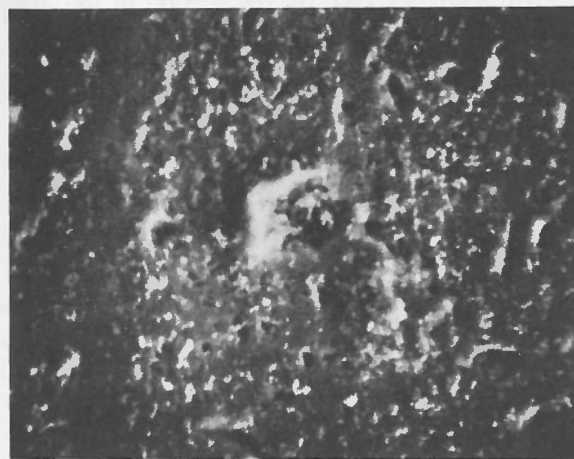
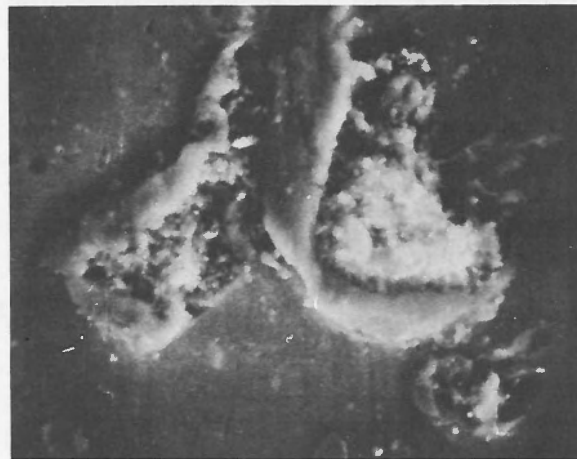
Figure 12 shows a region of high pitting density at 220° from the scribe line on section B. The

FIGURE 12.—Evidence of typical impact debris found on sections B and C of the Surveyor 3 polished tube.

crater in the center is about  $8\ \mu\text{m}$  in diameter; the material in this crater has as major components silicon, iron, calcium, and titanium. Titanium was also found in another crater on this tube. Because only six craters were extensively analyzed by SEM non-dispersive X-ray analysis, the significant amounts of titanium found in three of them are indicative of a lunar origin. From the mineralogical standpoint, at least three phases are present:

A crater that gave us some difficulty is the one shown in figure 12 at  $170^\circ$  from the scribe line. Its size is about  $80$  by  $110\ \mu\text{m}$  and is one of the largest craters on the tube. The reason for the difficulty was the surprising appearance of "rods" in the crater, which looked very much like glass fibers under an optical microscope. The SEM analysis showed them to be identical in composition to the glass fibers in the astronauts' outer garments and in the back pack in which the Surveyor 3 parts were stowed. Experiments at MSC have shown that it is possible to break a few fibers by jamming the end of a strand of beta-fiber into a crater of this size.
